FIRE RESEARCH AND DEVELOPMENT TECHNICAL REPORT

# Considerations for Fire Service Response to Residential Battery Energy Storage System Incidents

December 4, 2023

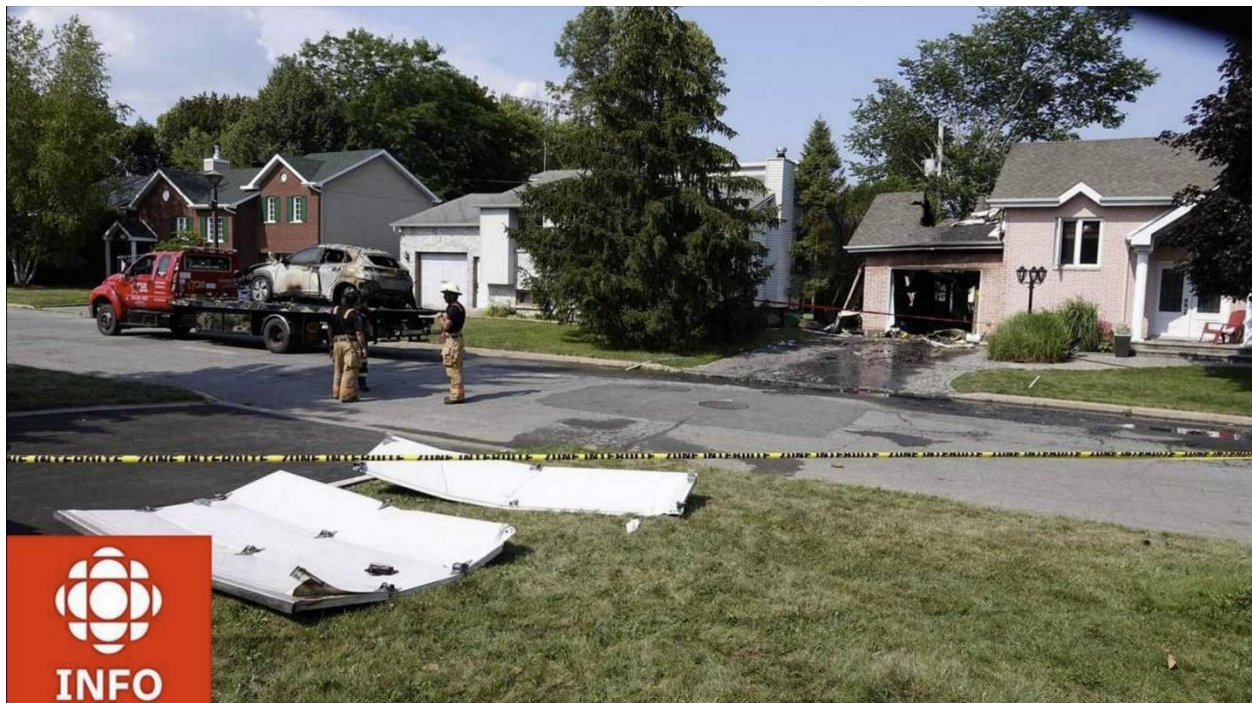
On July 27, 2019 a Hyundai Kona was parked in a residential garage in Île-Bizard, Montreal, Canada when it caught fire and later caused an explosion [19]. The car was purchased in March 2019 and was not plugged in according to the owner. He called the fire service at 1 pm after seeing dark smoke coming from the closed garage and turning off the breaker to the garage. No one was injured but the owner said “If we were in front of the garage door, we could have been in the hospital.” The fire service reported that they could find no other sources inside the garage besides the car that could have caused the explosion. Figure 12 shows the position of the garage door as encountered upon arrival of the first due engine company.

**Figure 12 – Garage condition following incident [19].**

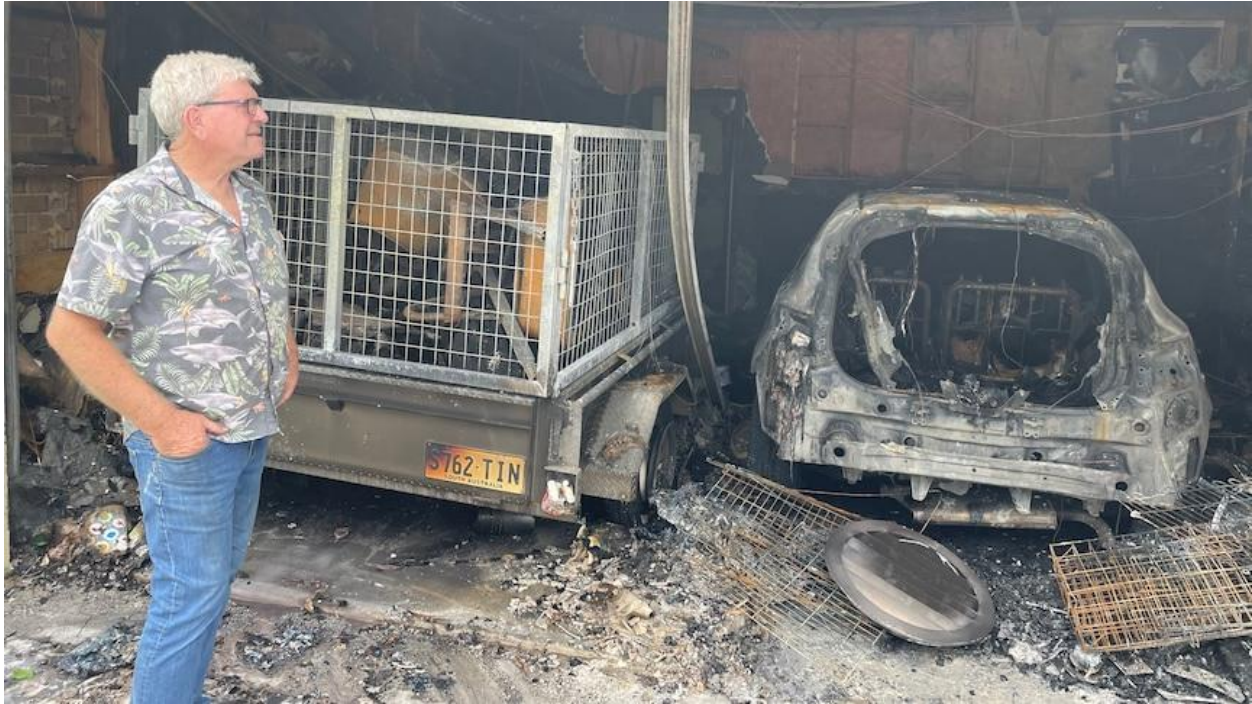
A resident of Burton, a suburb of Adelaide, was woken at 3 am on February 12, 2022 by his smoke alarm and bangs coming from the roof of his house. He called the fire service and then evacuated the house with the other residents. The fire started in the ESS for the solar system which was in the garage. No one was injured but the damage is estimated at \$200,000 AUD and the garage is a total loss [21]. Damages are shown in Figure 14.

**Figure 14 – Aftermath of Adelaide incident [21].**

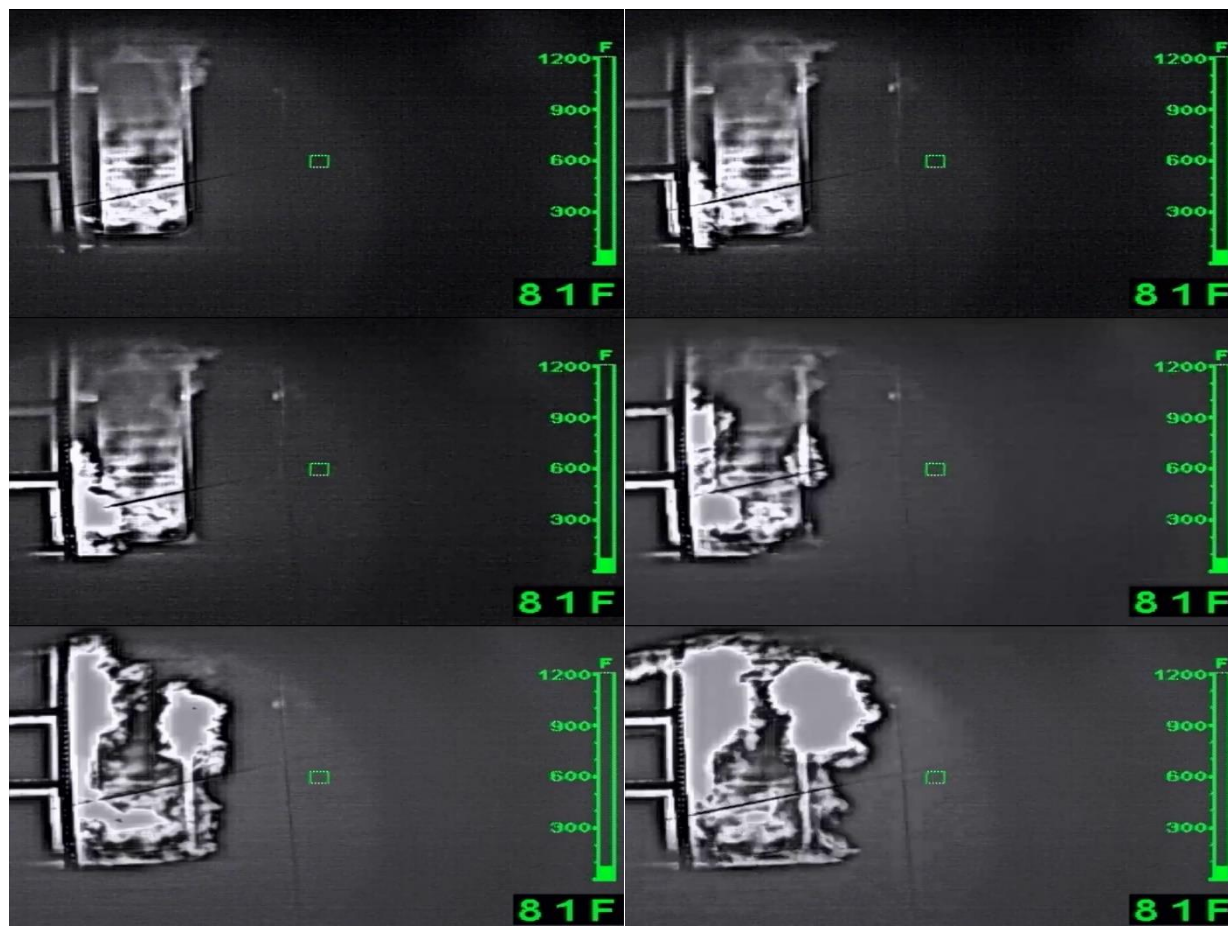
Infrared thermal imaging shows the ignition location at the face of the commodity box closest to the bottom left side of Unit 1, as shown in the sequence in Figure 101. At this location, hot gases generated from the ESS impinge directly onto the adjacent cardboard box.

**Figure 101 – Thermal image sequence of ignition and deflagration (36:24 to 36:26).**

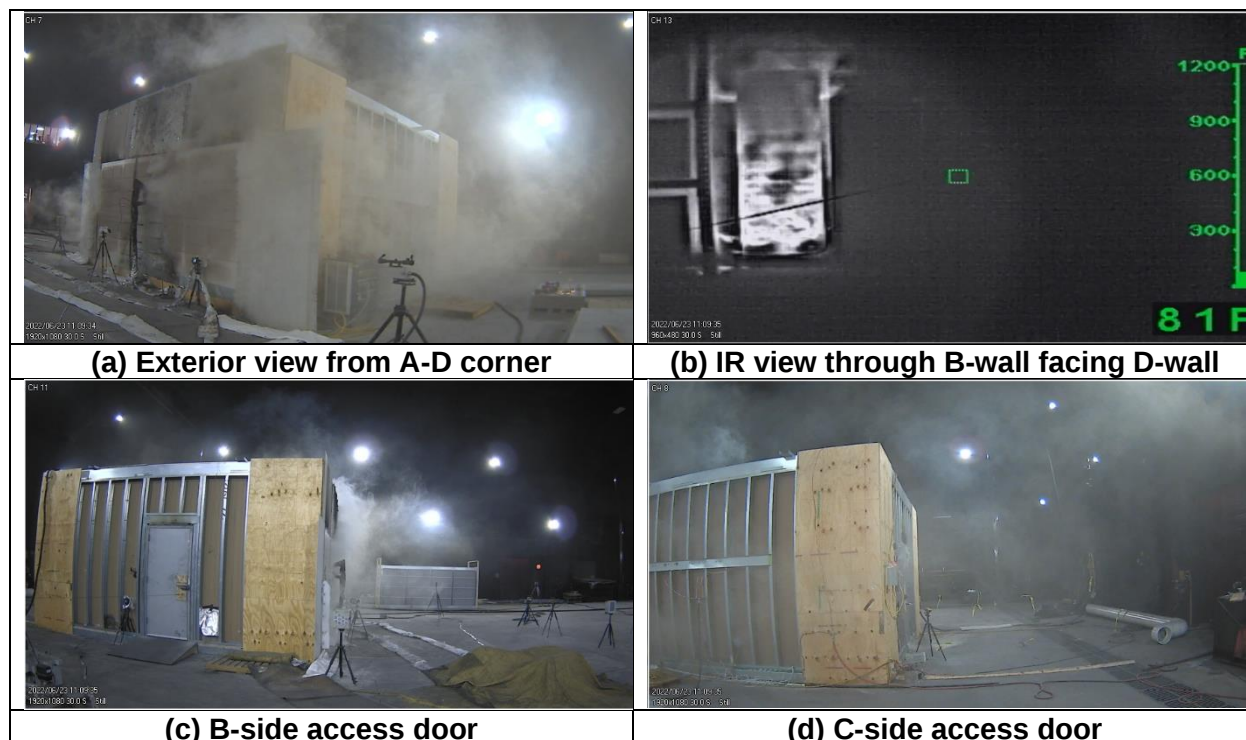
Figure 108 shows four views immediately prior to the deflagration. Interior IR views indicate active thermal runaway but do not provide an indication of the flammability of the environment or likelihood of the deflagration. Exterior images show significant gas leakage from around the garage door and roof of the structure. The buoyancy driven gases emit around all seams and kerfs of the garage door. The gases, which are battery thermal runaway effluent, appear light gray to white and are not distinct from ventilation-limited fire smoke. Traces of battery gas are visible around the seams of the C-side access door. No evidence of smoke is visible around the perimeter of the B-side access door.

Figure 108 – Visual conditions immediately prior to deflagration (36:26, TR + 15:56).

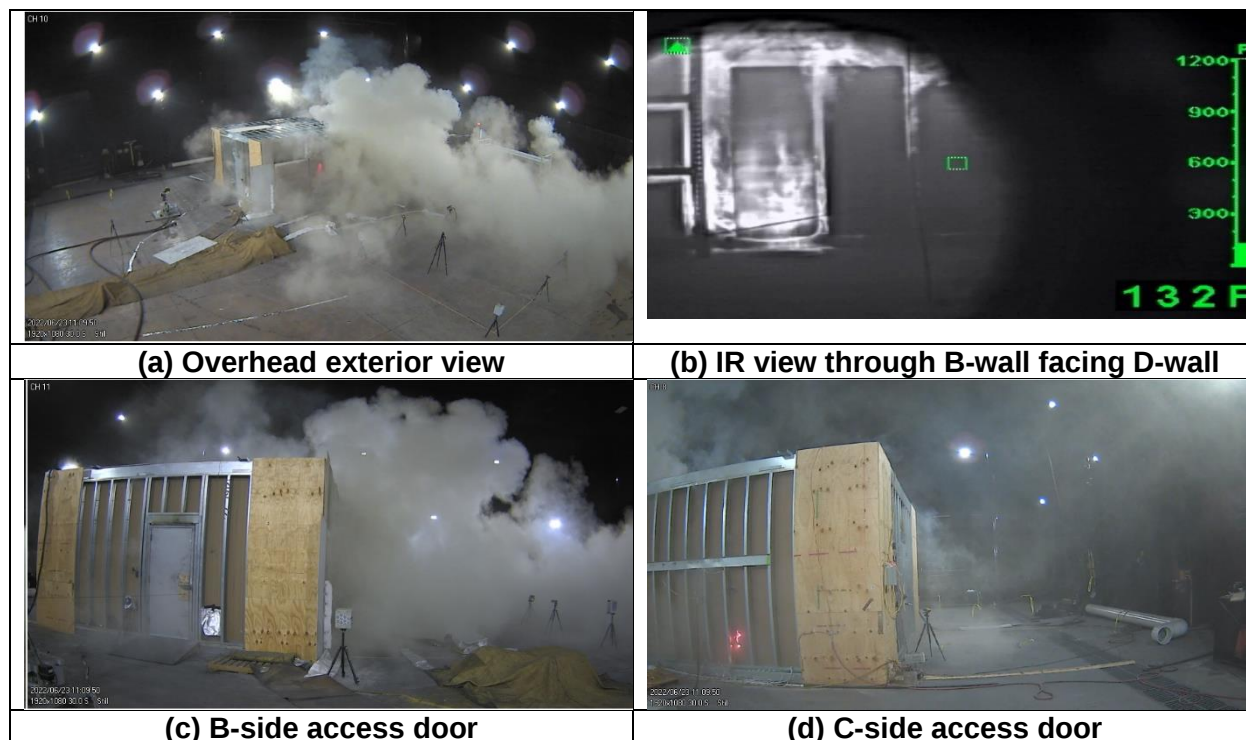
Figure 109 shows the environment of the garage 10 seconds after the deflagration. Interior IR imaging shows active thermal runaway activity with surrounding flaming. Exterior views show a significant cloud of gases, vapors and smoke pushed 60-70 ft across the lab. The quantity and positioning of vapor clouds could indicate to a firefighter that a deflagration has recently occurred, and that the situation requires added precautions. Even though the garage door damage was limited, the surrounding environment indicates the occurrence of a deflagration event. Additionally, flaming is visible in penetrations on the D-side wall and small amounts of battery gas is visible around the perimeters of both the B-side and C-side access doors.

**Figure 109 – Conditions 10 seconds after deflagration (36:36, TR + 16:06).**

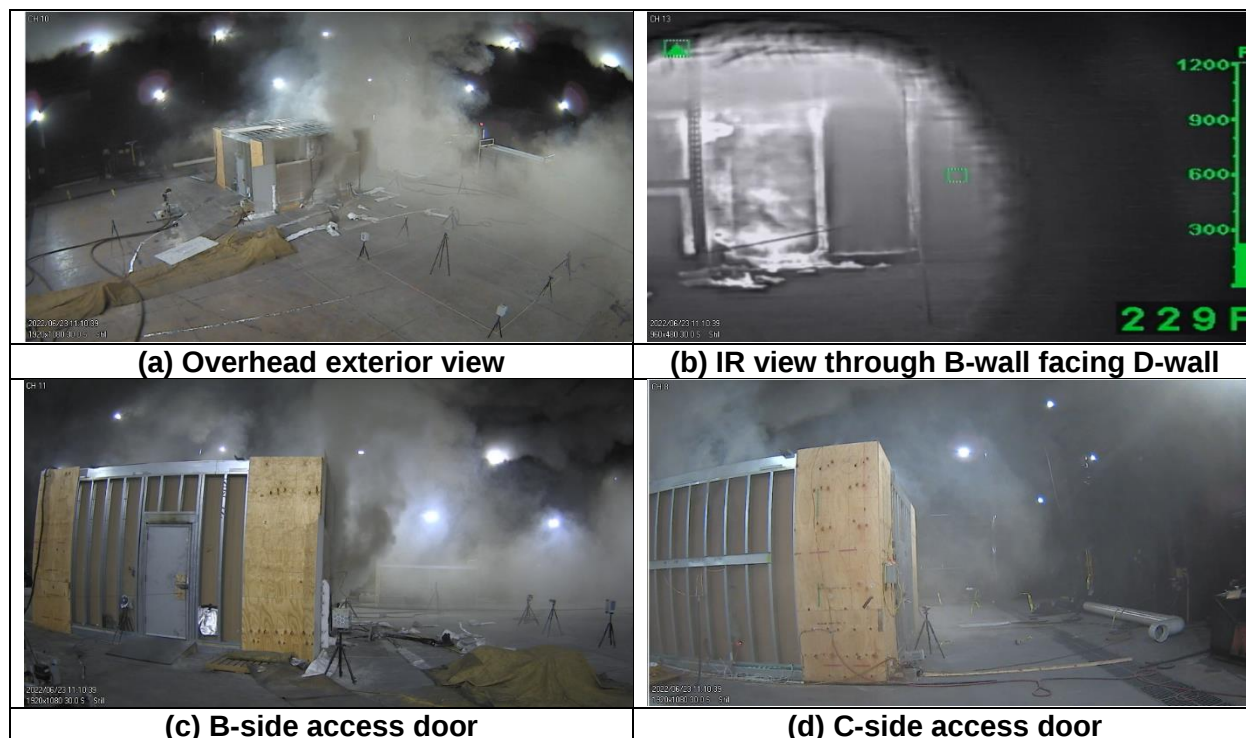
**Figure 110 – Conditions 1 minute after deflagration (37:26, TR + 16:56).**

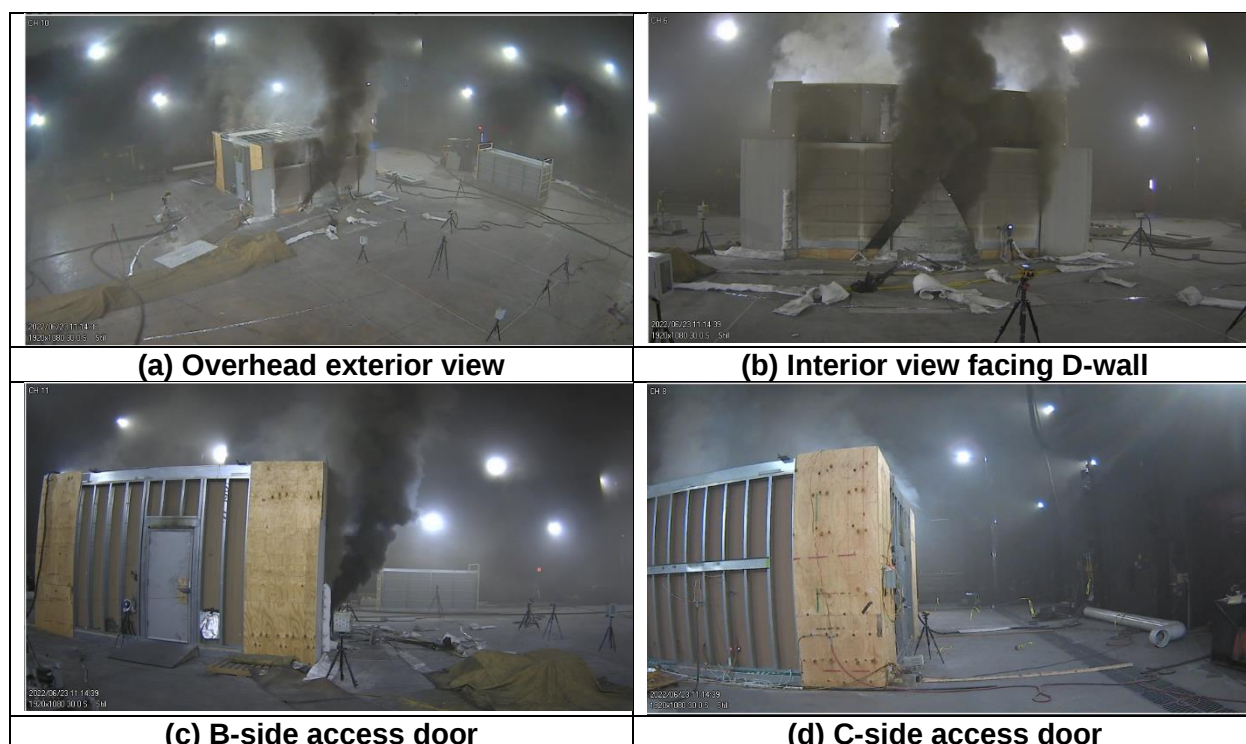
Figure 111 – Conditions 5 minutes after deflagration (41:26, TR + 20:56).

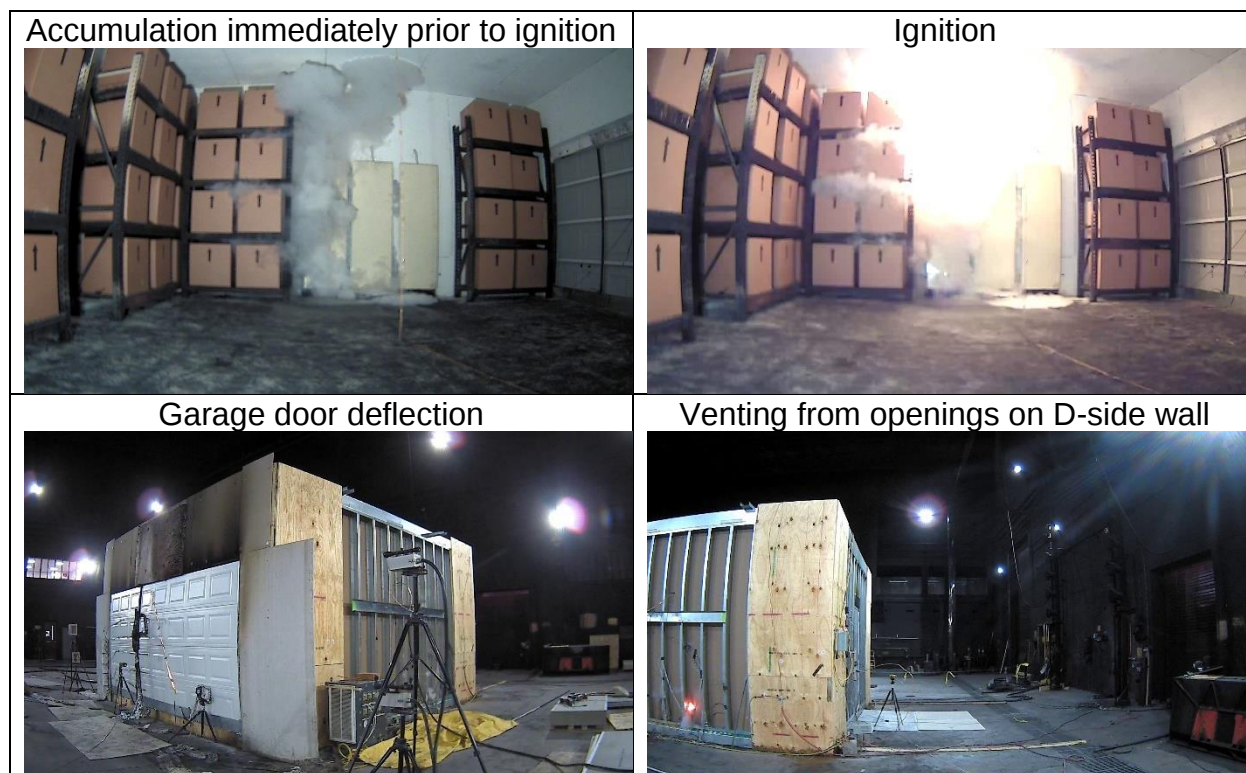
**Figure 151 – Battery gas ignition at 27:41 (TR + 02:20).**

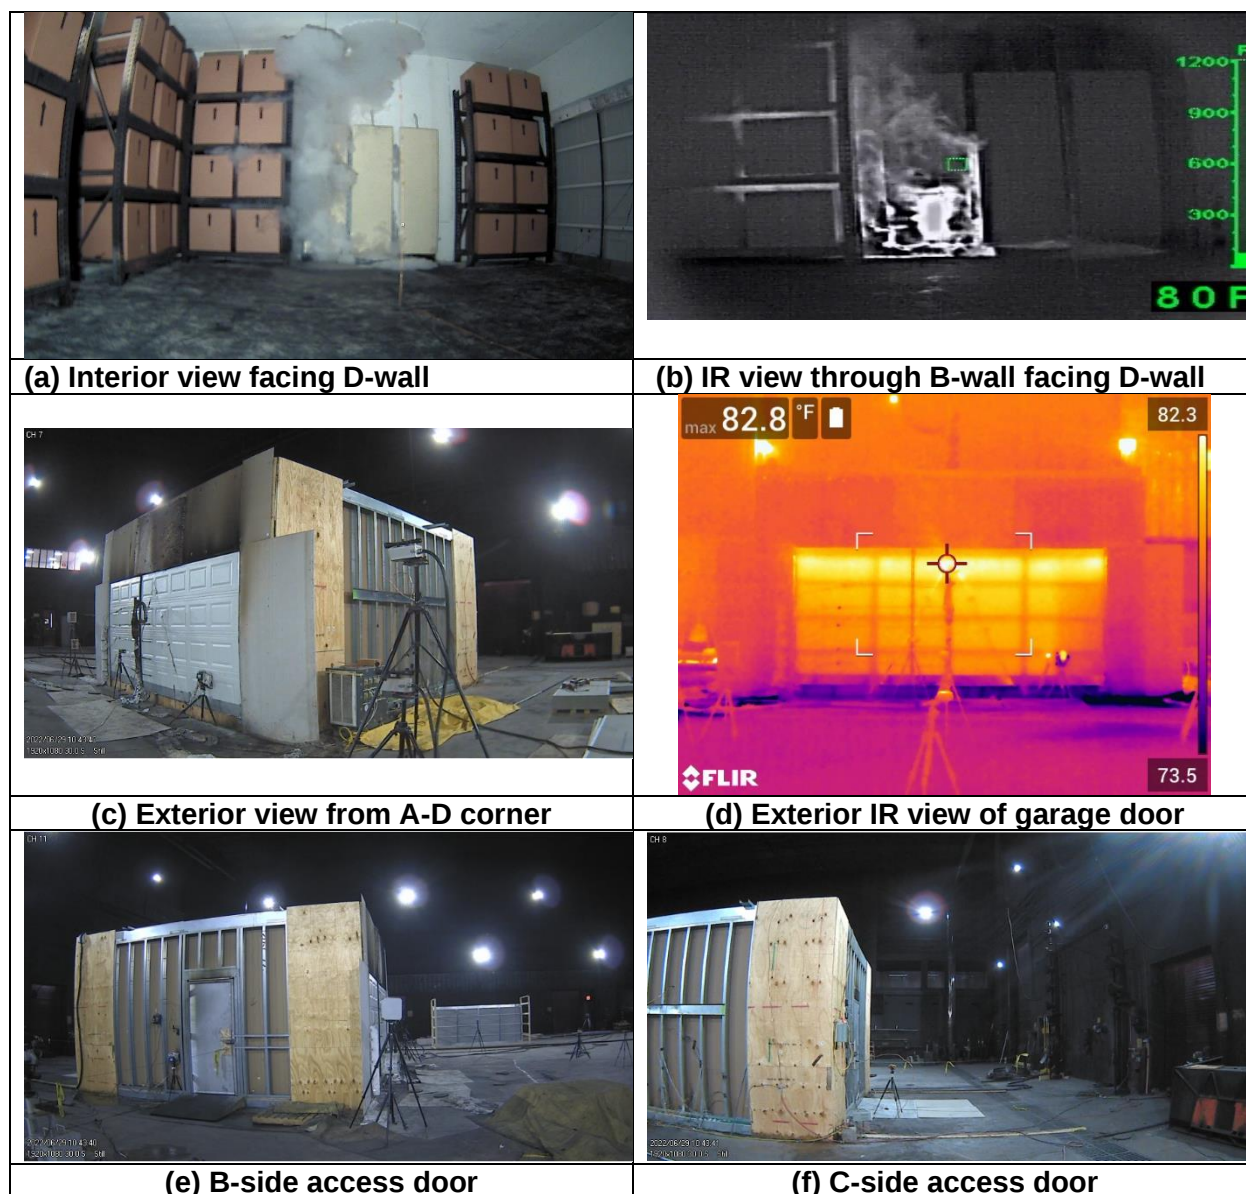
Figure 169 – Gas accumulation before ignition (27:40, TR + 02:19).

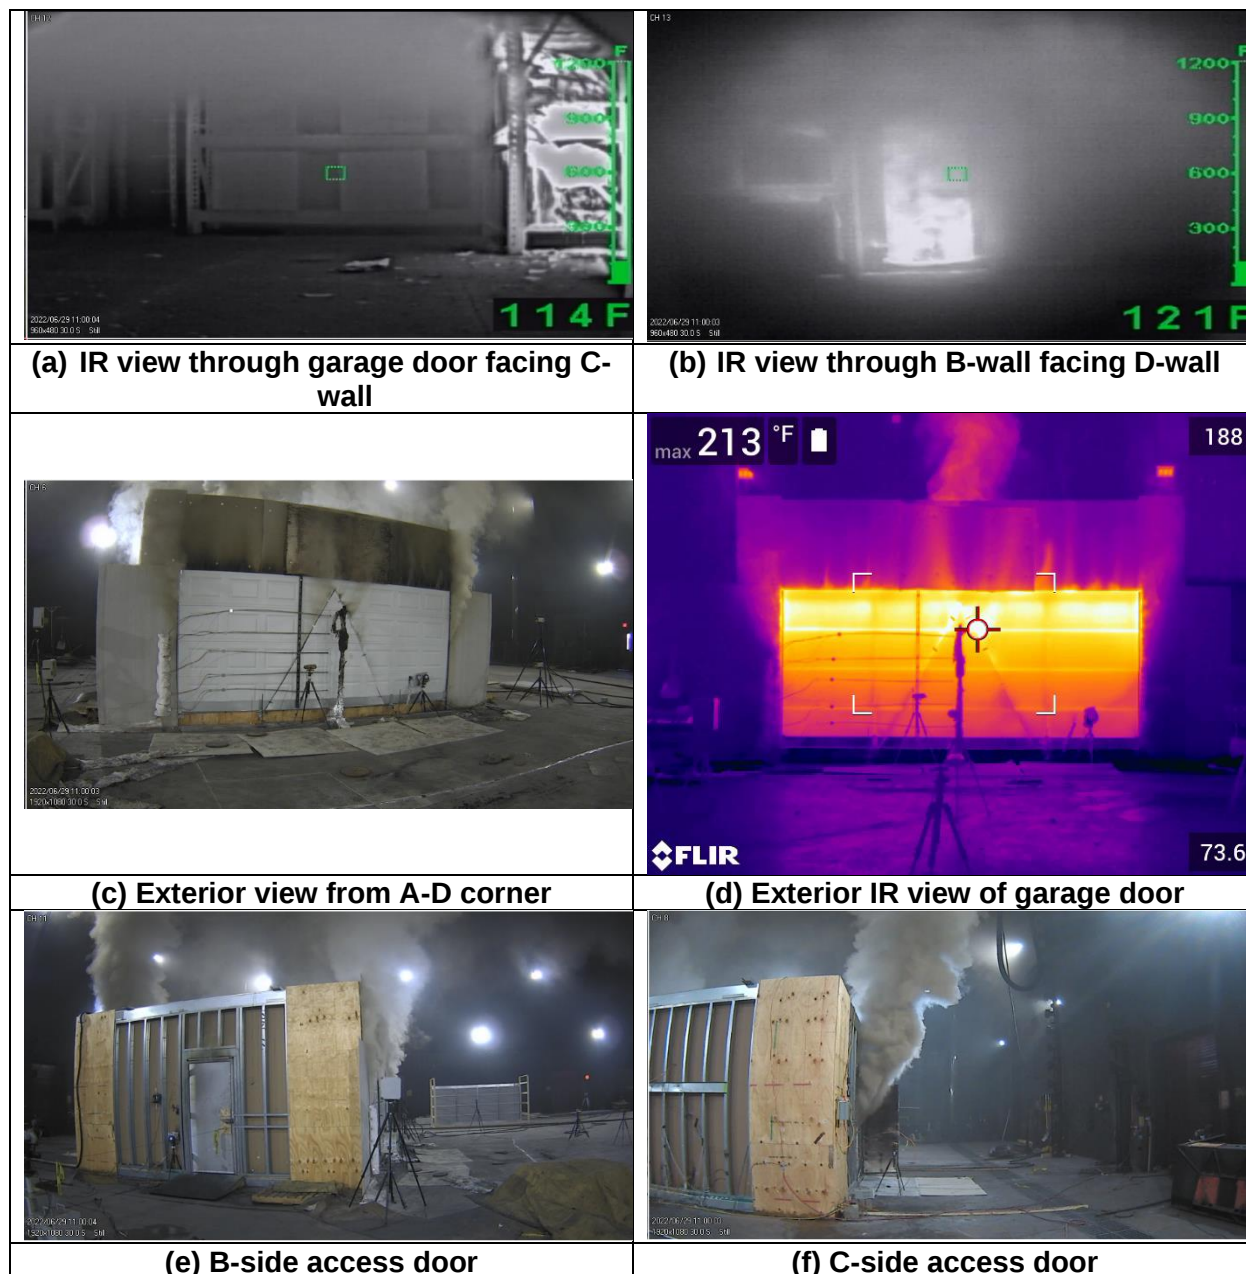
Figure 175 – Conditions prior to backdraft (44:03, TR + 18:42).

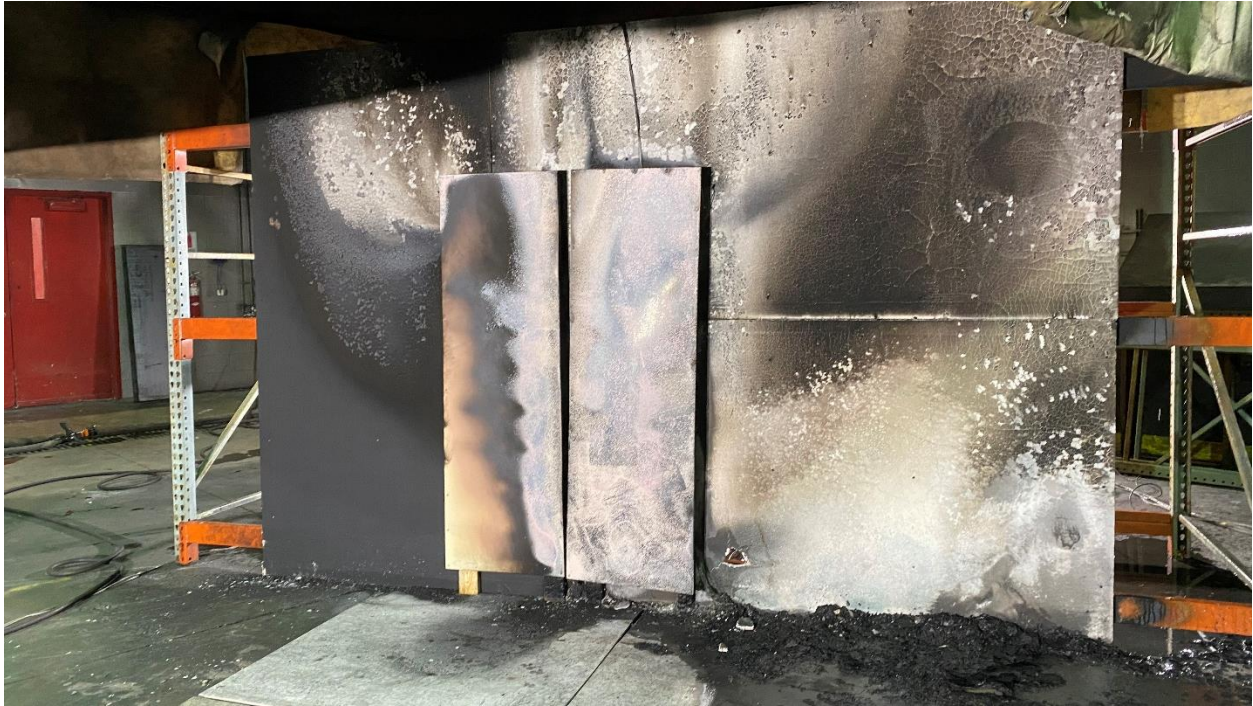
**Figure 195 – Post-test condition of ESS units and Commodity boxes in Scenario 1.**

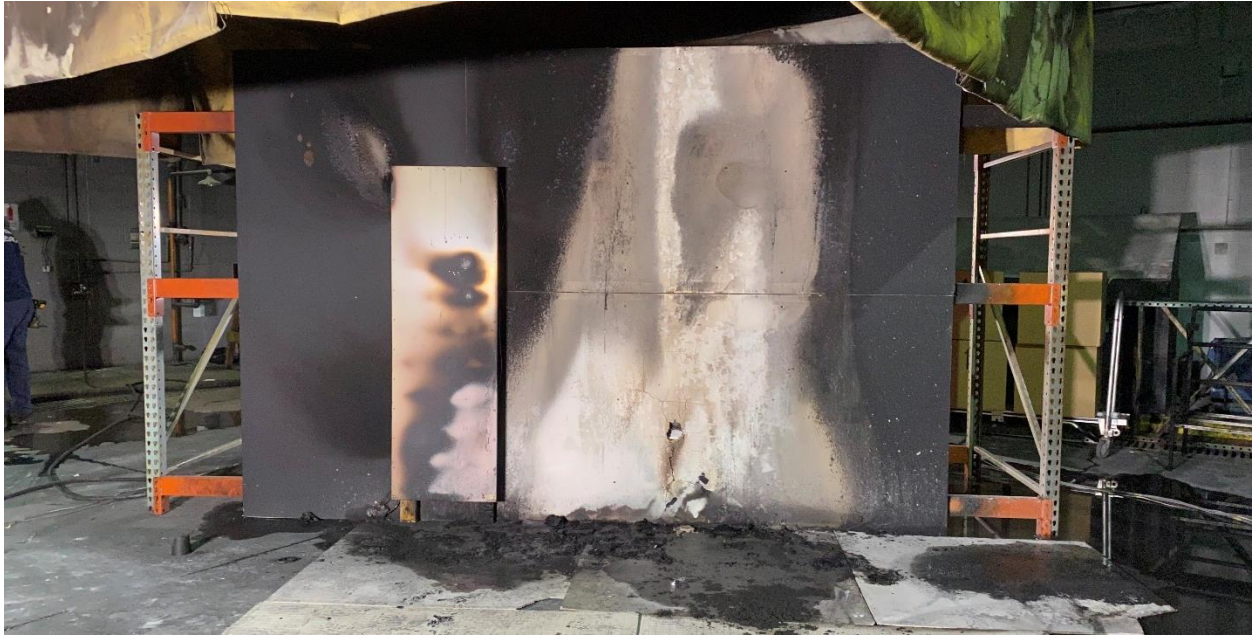
**Figure 199 – Post-test condition of ESS unit and Commodity boxes in Scenario 2.**
