FIRE RESEARCH AND DEVELOPMENT TECHNICAL REPORT

# Considerations for Fire Service Response to Residential Battery Energy Storage System Incidents

December 4, 2023

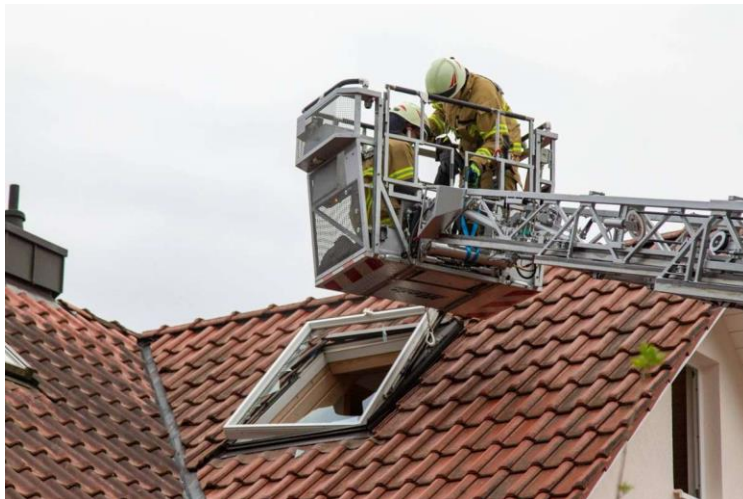
At approximately 5:20 pm a woman reported a fire in the basement of a house in the Coburg area. The fire service was able to bring the fire under control, but an explosion occurred during this process. The source of the fire was later identified as a technical defect in the ESS of a solar system. The two residents had initially attempted to fight the fire themselves and were later taken to the hospital for smoke inhalation [16]. Figure 9 shows some of the damage following the explosion and fire fighter operations.

**Figure 9 – Damage to window during incident [16].**

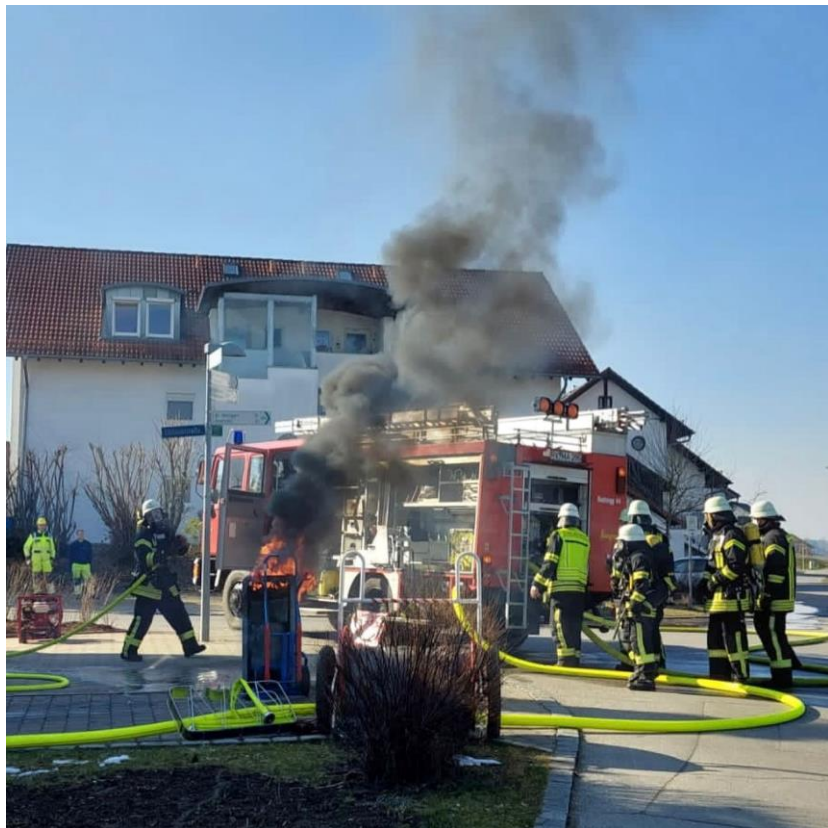
According to police investigation, at around 2 pm the ESS of a solar system exploded in the basement of a house in Bodnegg, Germany. The cause is suspected to be a technical defect in the system. The explosion was strong enough to push out several doors and windows and to lift the entire roof structure. No one was injured but the building was rendered uninhabitable with an estimated €250,000 of damages. The fire service sent five vehicles and 30 firefighters to fight the fire [17]. A technician from the local electrical utility service came to switch off power to the building and a master electrician pulled the fuses allowing the fire service to remove the ESS from the house. According to the fire service, the system reignited as it was brought outside and it was finally extinguished and put in a tank of water to cool it down and prevent further reignition [11]. This sequence of events is shown in Figure 10 and Figure 11.

Figure 10 – Burning ESS after removal from residence [17].

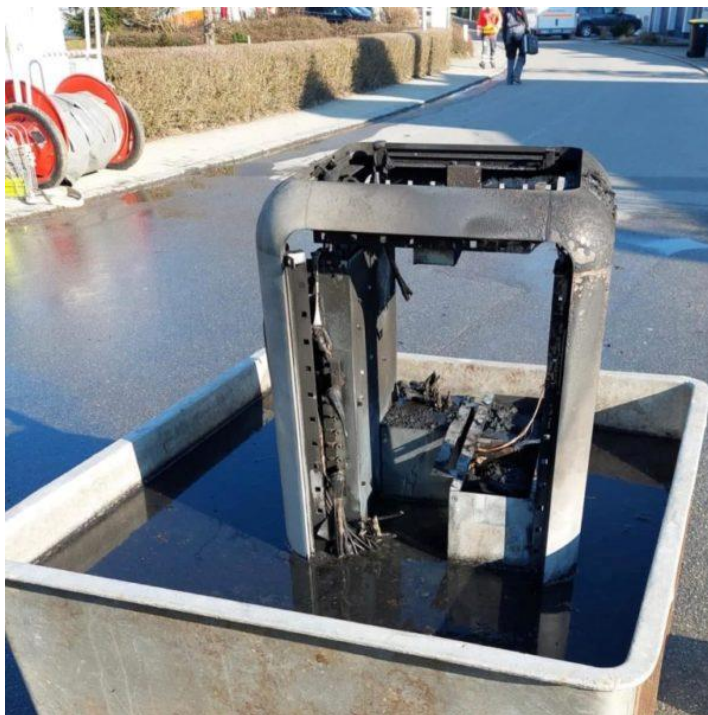
Figure 11 – ESS unit condition after firefighting operations [11].

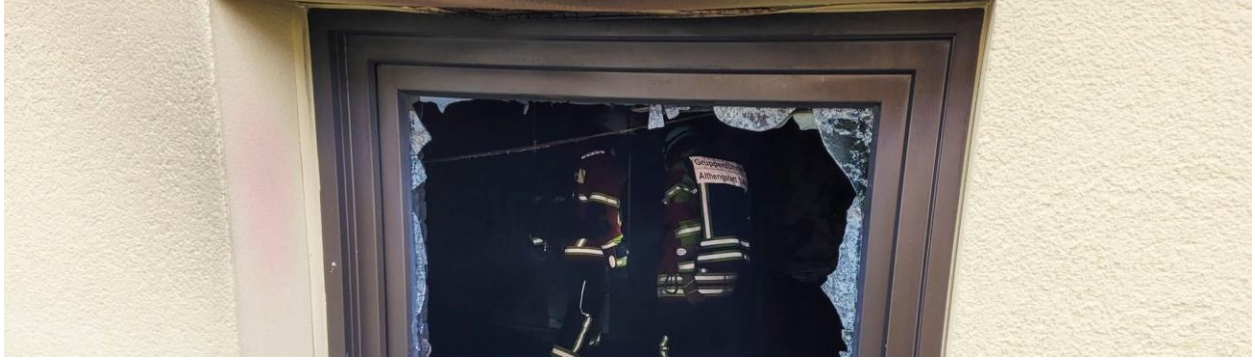
On May 9, 2022, the fire service was called due to reports of white smoke coming out of a house's basement where an ESS for a solar system was located. An explosion occurred shortly before the fire service arrived. The explosion blew out the basement windows and doors, and the doors in the house as well. No one was injured but the damages are estimated at €400,000 to €500,000 and the house is uninhabitable [23]. The fire operations manager said, "I'm so glad the explosion happened before my attack squads entered the house. I can't imagine what could have happened there." The fire was brought under control and the remains of the ESS were submerged in water to cool it and prevent reignition. A sequence of key images is shown in Figure 15 - Figure 17.

**Figure 15 – Window damaged by explosion [23].**

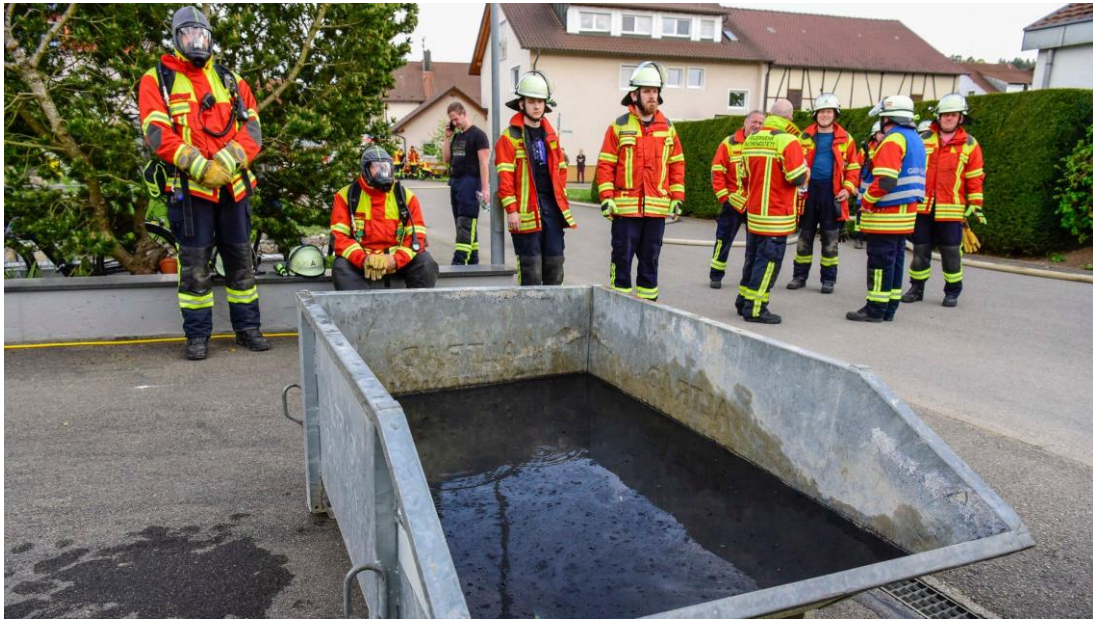
**Figure 16 – Fire service responding to incident [23].**

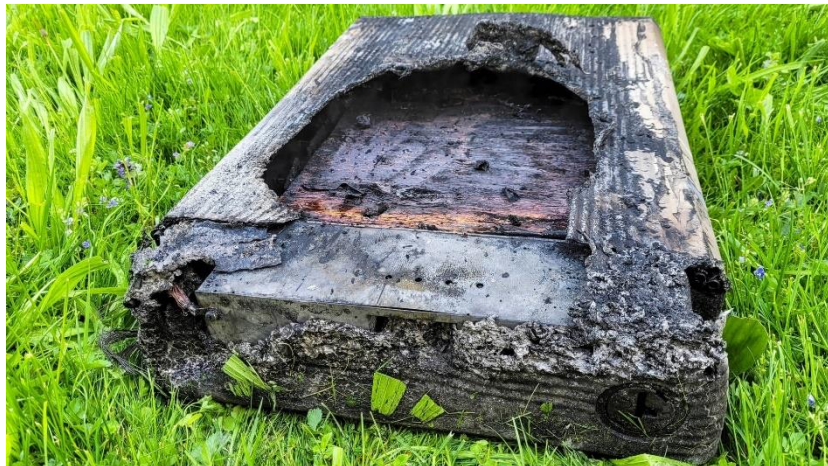
**Figure 17 – Battery condition following incident [23].**

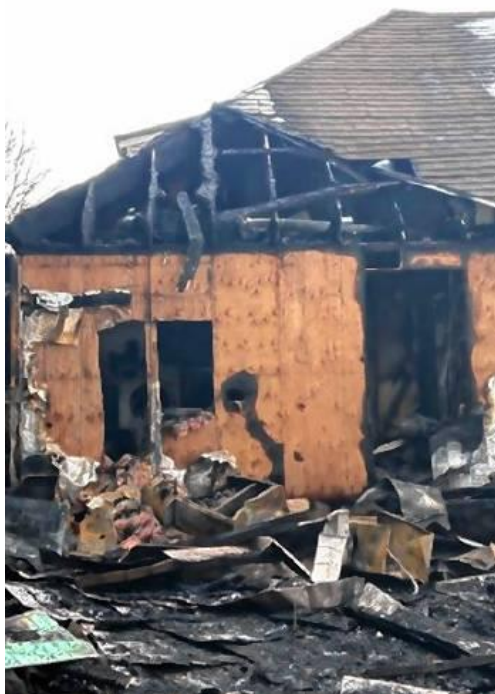
On Saturday, December 17, 2022, one woman was injured in a fire resulting from a battery backup system that was utilized during a power outage. The battery system was installed in a mechanical room and constructed from three used lithium-ion batteries repurposed from Chevy Volt cars [24]. When the homeowner investigated a “popping” sound, she described the battery as “bubbling over” and when she returned with a fan, the battery was on fire with flame extension to the ceiling, at which point the local fire department was called. Figure 18 is a photograph of the incident after the fire.

**Figure 18 – Fire damage to property following lithium ion battery thermal runaway [24].**

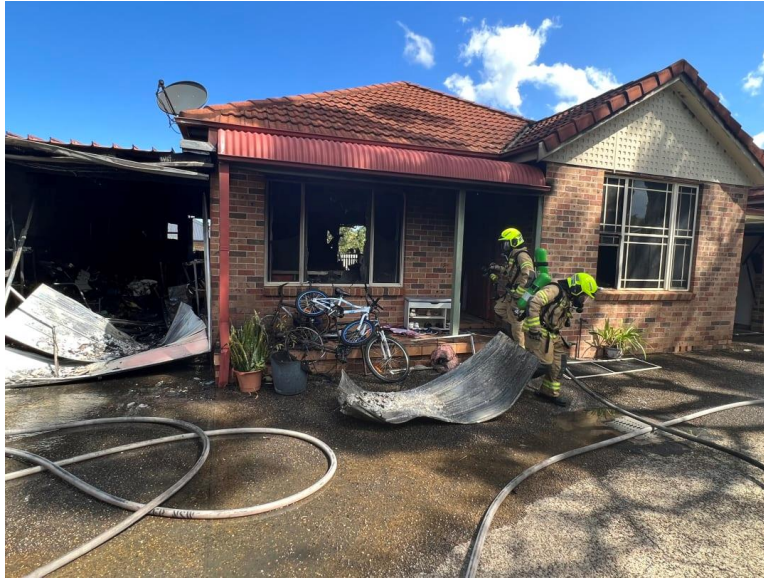
A fire on 15 February 2023 in Epping, Sydney, Australia was found to be caused by a faulty li-ion battery by Fire and Rescue New South Wales. No one was injured but the house experienced significant damage. This incident highlights the challenges of second-life batteries in residential ESS systems due to the unknown history of the battery and how that affects the probability of it experiencing thermal runaway [25]. Figure 19 shows the condition of the home after the fire.

**Figure 19 – Conditions after fire caused by residential ESS [25].**

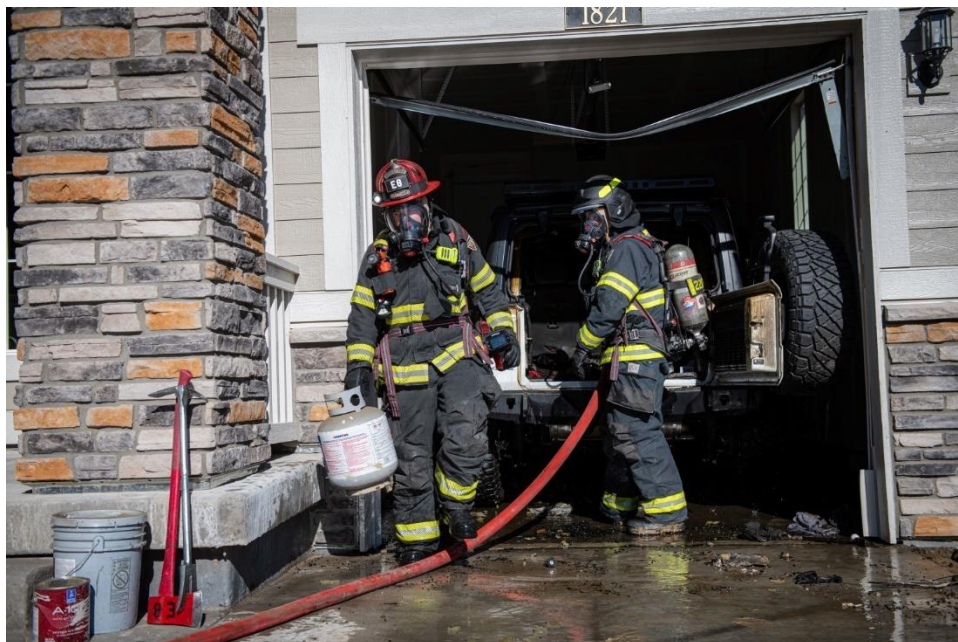
Figure 20 – Responding firefighting crew [26].

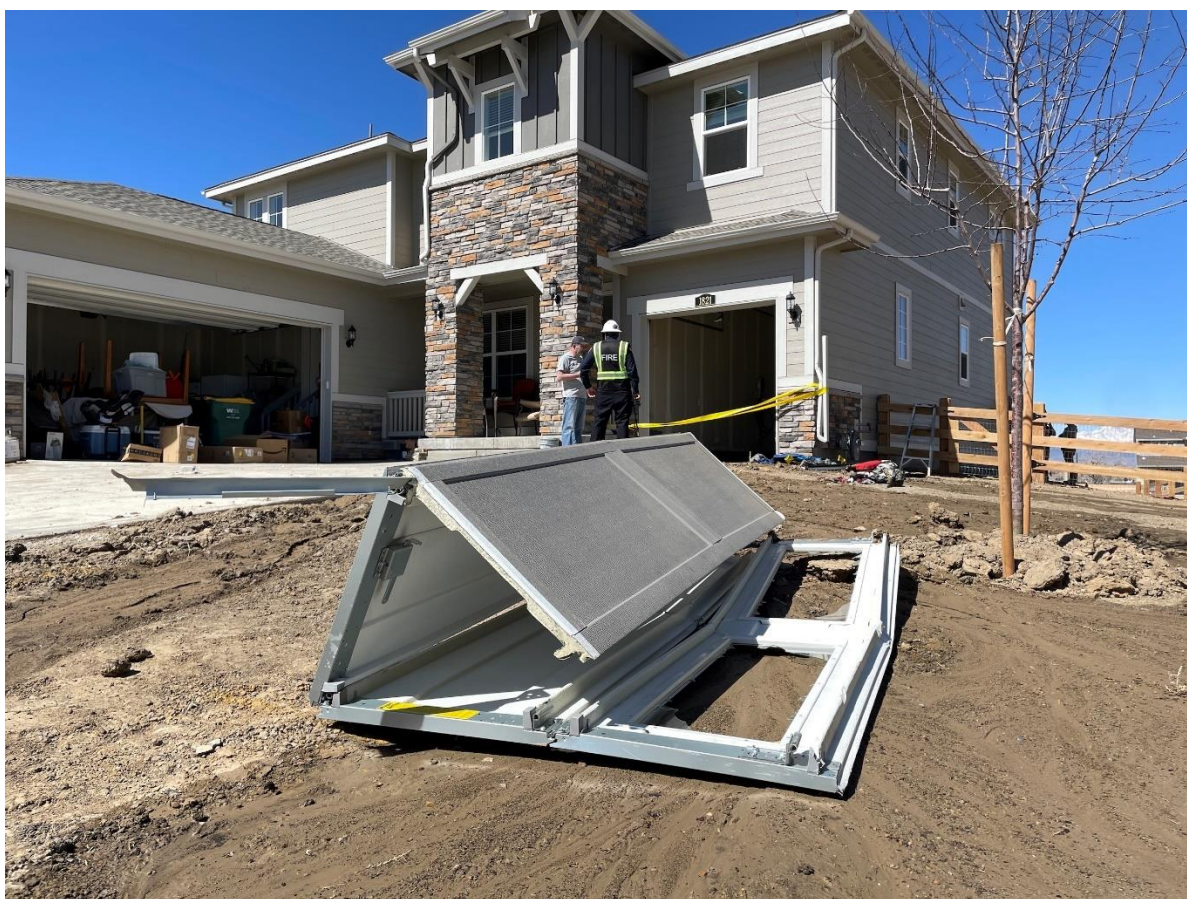
On the morning of April 11, 2023, Mountain View Fire Rescue responded to a reported structure fire. There was no smoke showing at the time the crews arrived. Firefighters searched the first floor of the home to identify the source of the smoke. Smoke was found to be coming from the secondary garage. Within the garage, a Jeep Wrangler 4XE hybrid was smoking and a dense smoke condition had formed. An explosion involving the burning of this dense smoke layer occurred while firefighters applied water to the vehicle. The explosion propelled the garage door 30 ft into the yard. No one was injured [26], though the garage door came into contact with the helmet of the incident commander as it traveled through the air. Figure 20 shows the condition of the garage after the explosion. Figure 21 shows the position of the garage door after the explosion.

Figure 21 – Garage door location following garage explosion [26].
